Inspection Report

Minerals Regulatory Program

Mine Name: Expectation
Operator Name: Mark Miller

Permit number: M0350024
Inspection Date: May 5 and May 9, 2006
Time: 11:40 AM to 12:45 PM on May 5; 12:15-1:10 PM on May 9

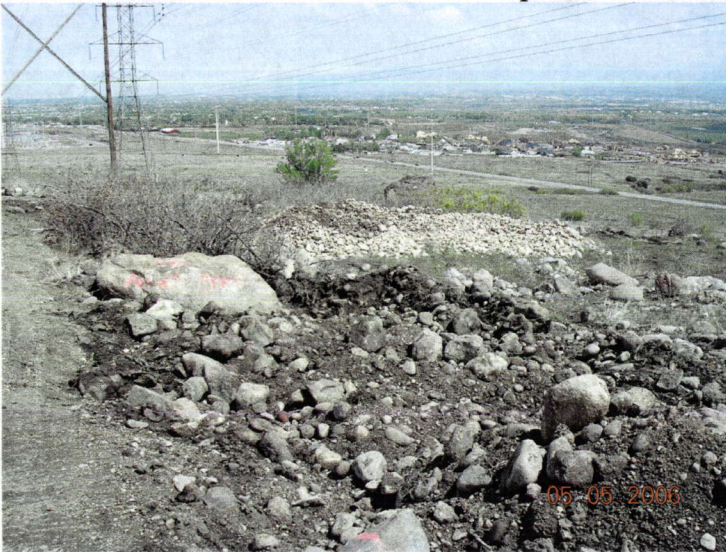
I collected GPS data around the perimeter of the disturbed areas, and the map created from this data is attached to this report. Some of the areas were obviously disturbed recently, such as those shown in Photos 1 through 3, 6, and 7. Other areas were disturbed last year and have not been redisturbed. In

Photo 1. Recent disturbance.

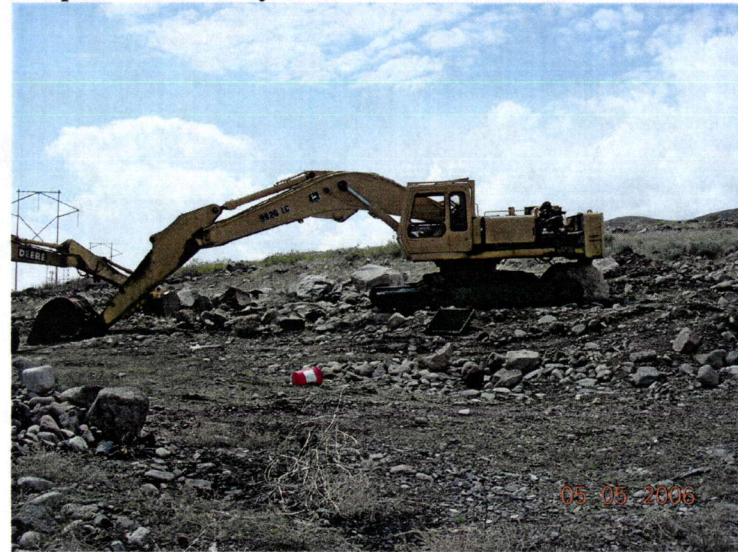
There are three trackhoes on site, one of which is not operational (Photo 3). The tracks and other parts have been removed from the trackhoe shown in Photo 3. There is a set of tracks lying on the surface in another part of the disturbed area (Photo 4).

Photo 3. The trackhoe in the center of the picture did not have tracks or some other vital parts, like a radiator. The one just barely visible on the left had been moved by the May 9 inspection.

The unoperational trackhoe and the tracks are reclamation liabilities to the Division. The operator needs to remove them from the site.

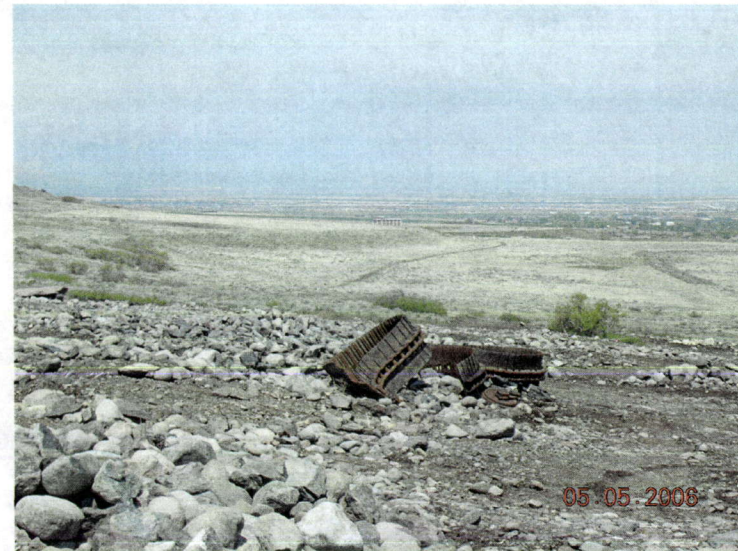
Photo 4. Tracks in an upper disturbed area.

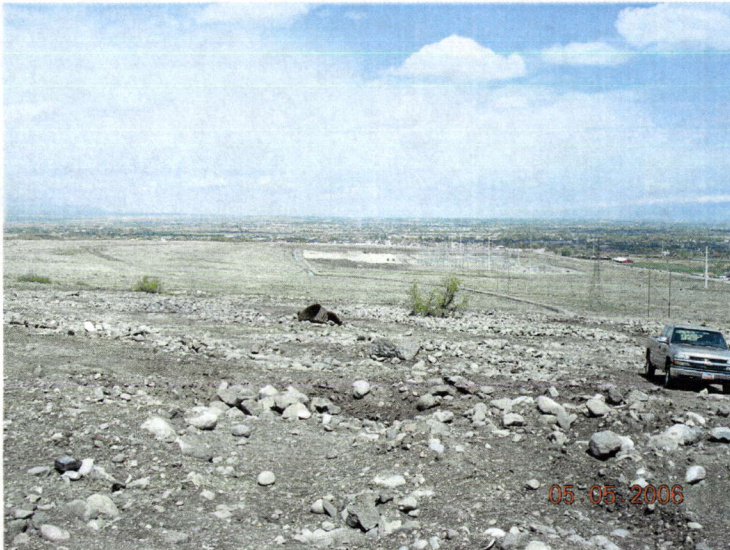
Most of the disturbance is in large blocks, such as shown in Photos 2 and 5, but there are several other places where individual small disturbances have been created along the edges of roads and in other areas (Photo 8).

Photo 5. This is the western portion of the disturbed area. Much of this disturbance is permitted.

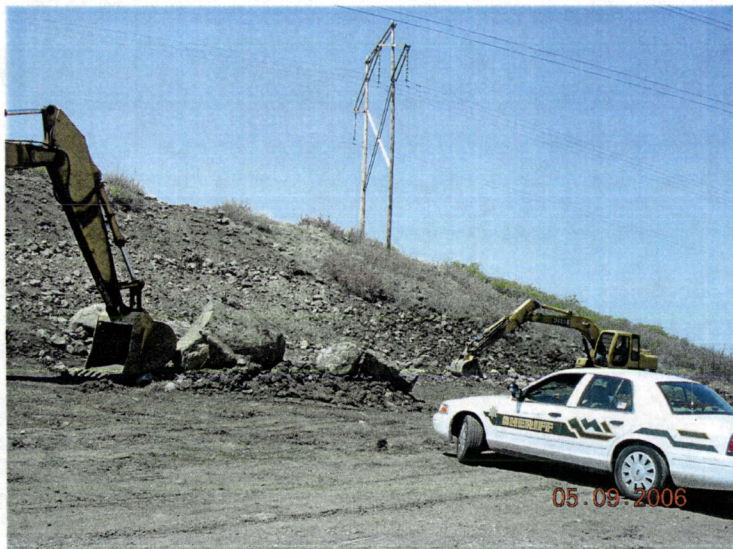
Photo 6. Another view of the disturbance shown in Photos 2 and 6.

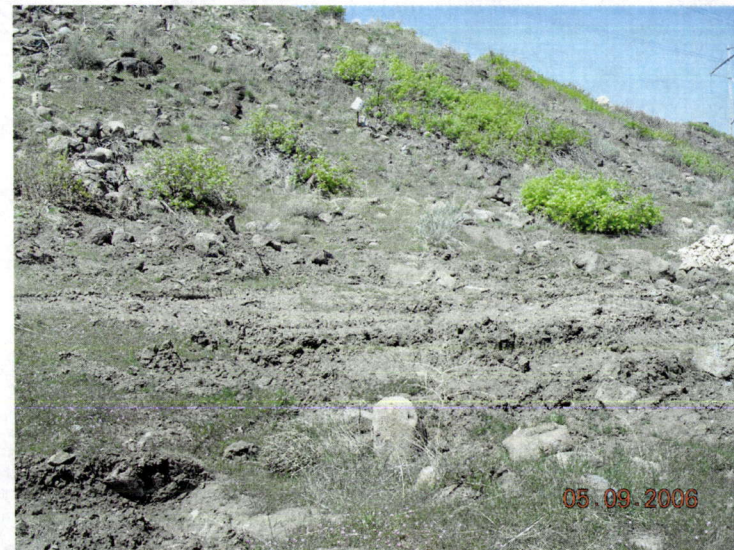
Photo 8. Some of the disturbance is small pockets from which it appears rocks have been removed.

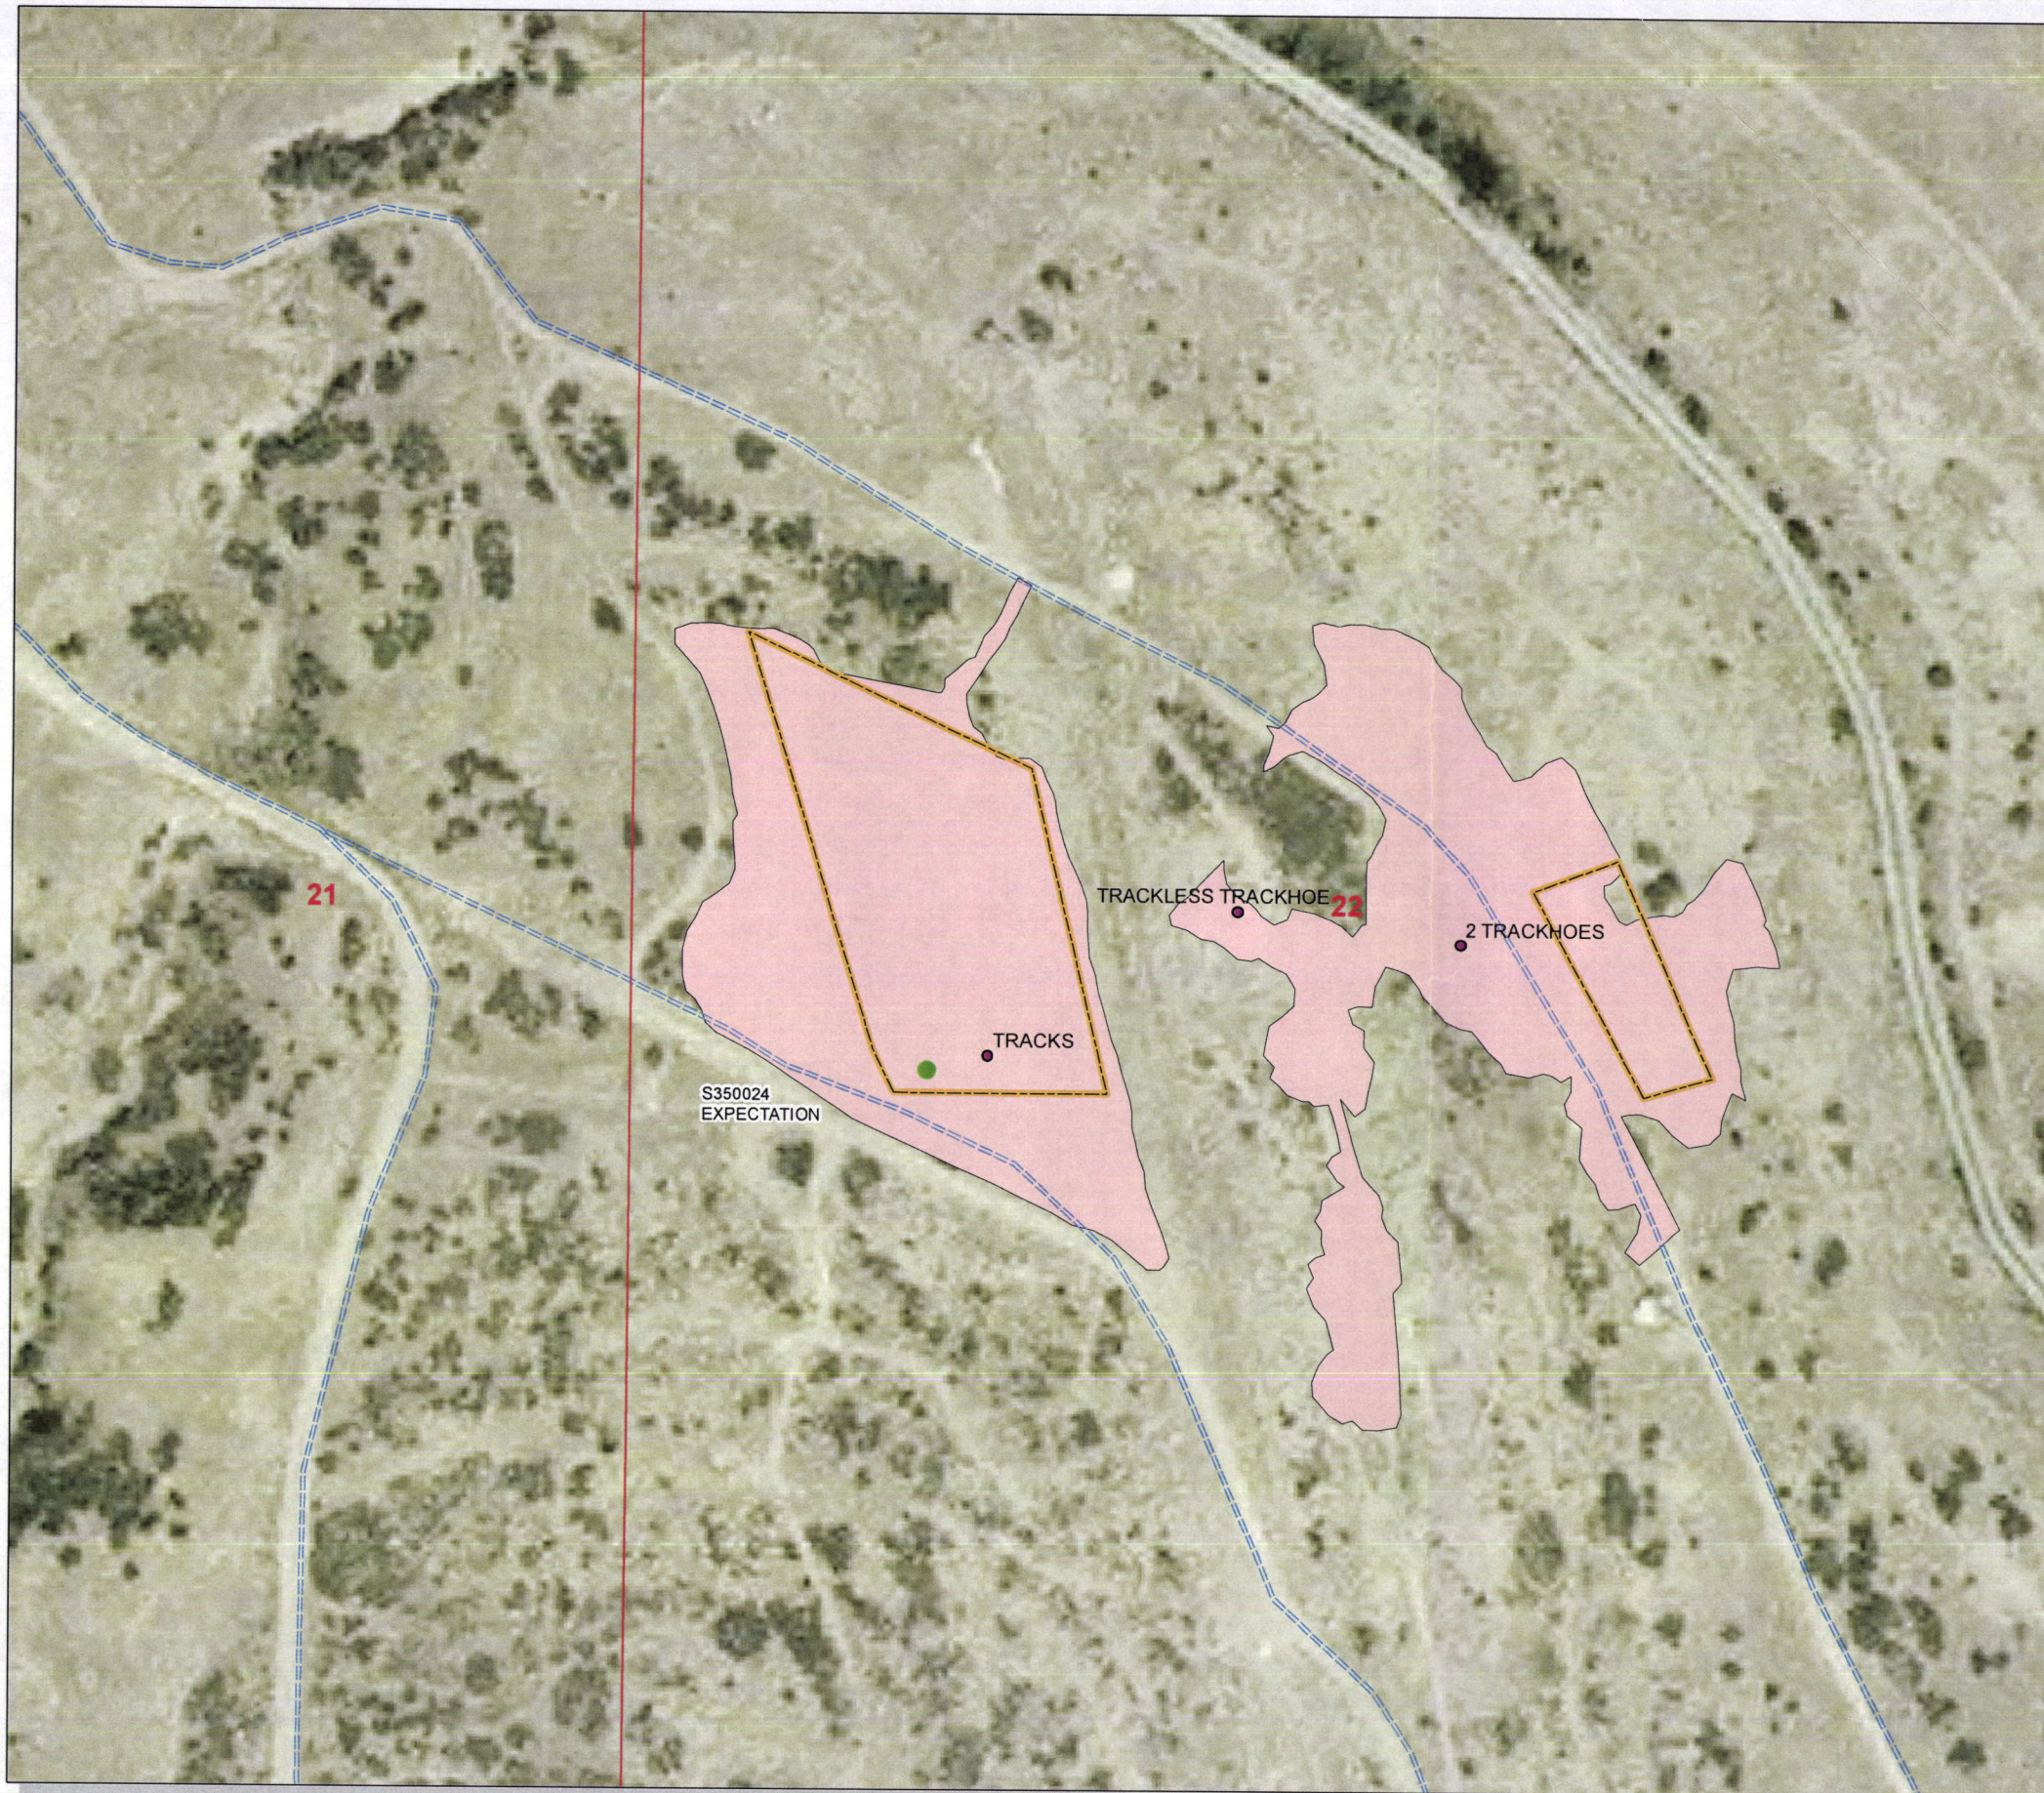
Mine Number: S350024
Mine Name: Expectation
Township 04 S Range 01 W Section 22 SLBM

The total area disturbed by mining operations is at least 10.03 acres, and much of the disturbed area is outside the area included in the Notice of Intention to Commence Small Mining Operations. For this reason, I have issued cessation order MC2006-03-04-01. The area I mapped as being disturbed is the minimum disturbed area. There are places outside this area that were probably disturbed by the operator, and the actual disturbed area could be as much as about 13 acres.

Acres Disturbed	10.03
Acres Regraded	0
Acres Seeded	0
Road Acres Disturbed	0

The reclamation surety amount for this site is the minimum that would be required to reclaim the area shown in the notice; it is not adequate for reclamation of 10 acres or more and for removal of the equipment. For this reason, abatement of the cessation order includes submittal of additional surety. The operator is being given the option of reclaiming the area or submitting a Notice of Intention to Commence Large Mining Operations.
